Service Log AN/GRC-109 communication system  
PP2684/GRC109 rebuild  
26-Dec-2019, Virgil Cheng vr2xgm

Power section service history:

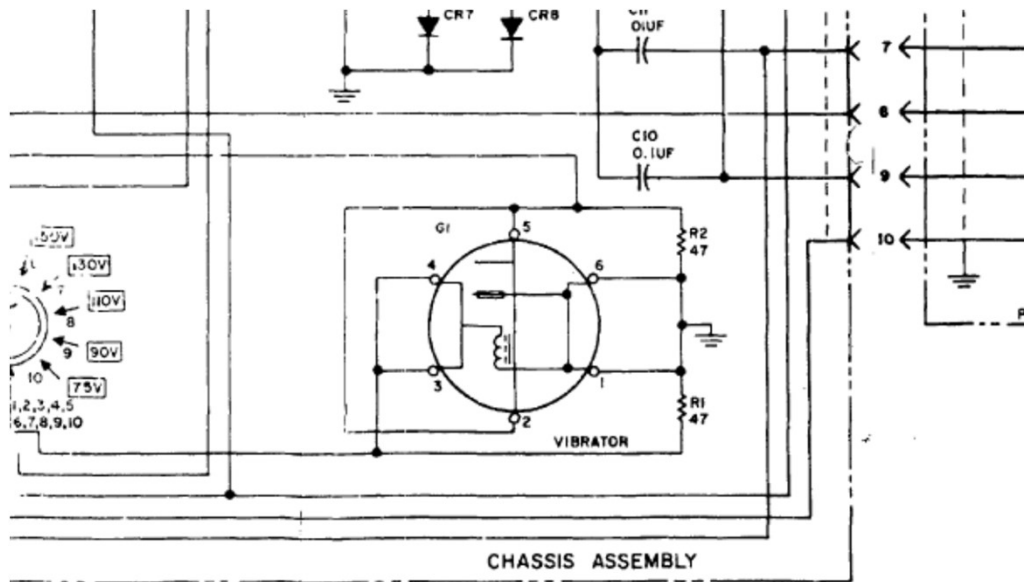
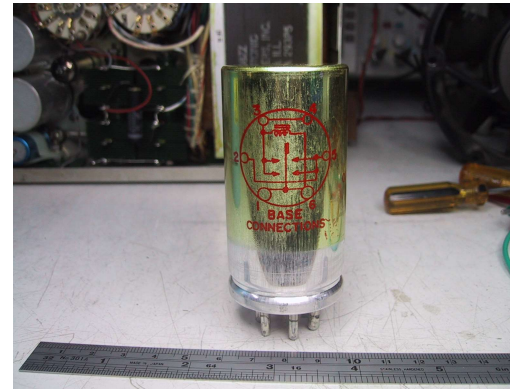
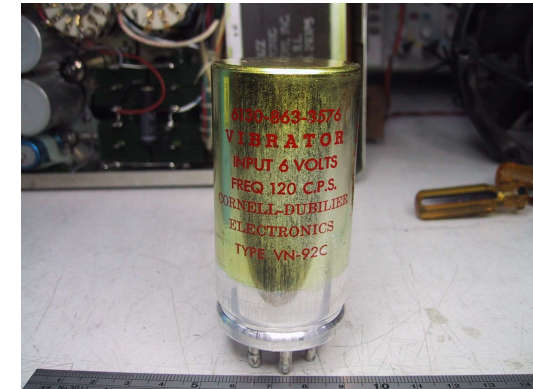
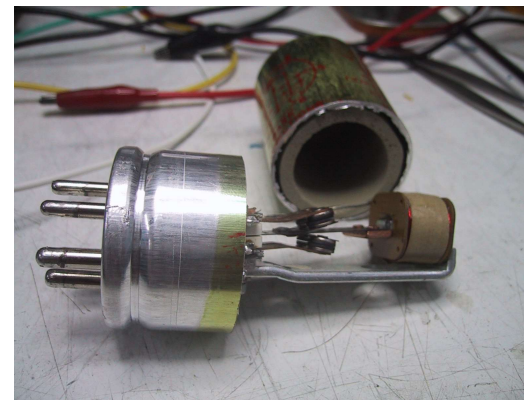
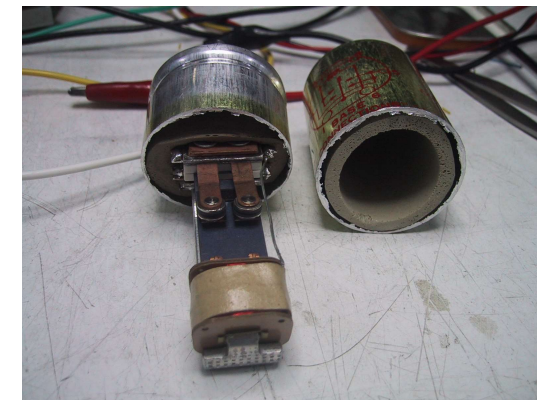
- Vibrator G1 had contact problem, was replaced with a home built electronic unit back in 11-Nov-2005

This VN-92C by Cornell-Dubilier was difficult to find, it was rebuilt with a solid-state replacement

Adjust R1//R2,R4 for 240Hz output  
Adjust R4 for ~1mS deadtime

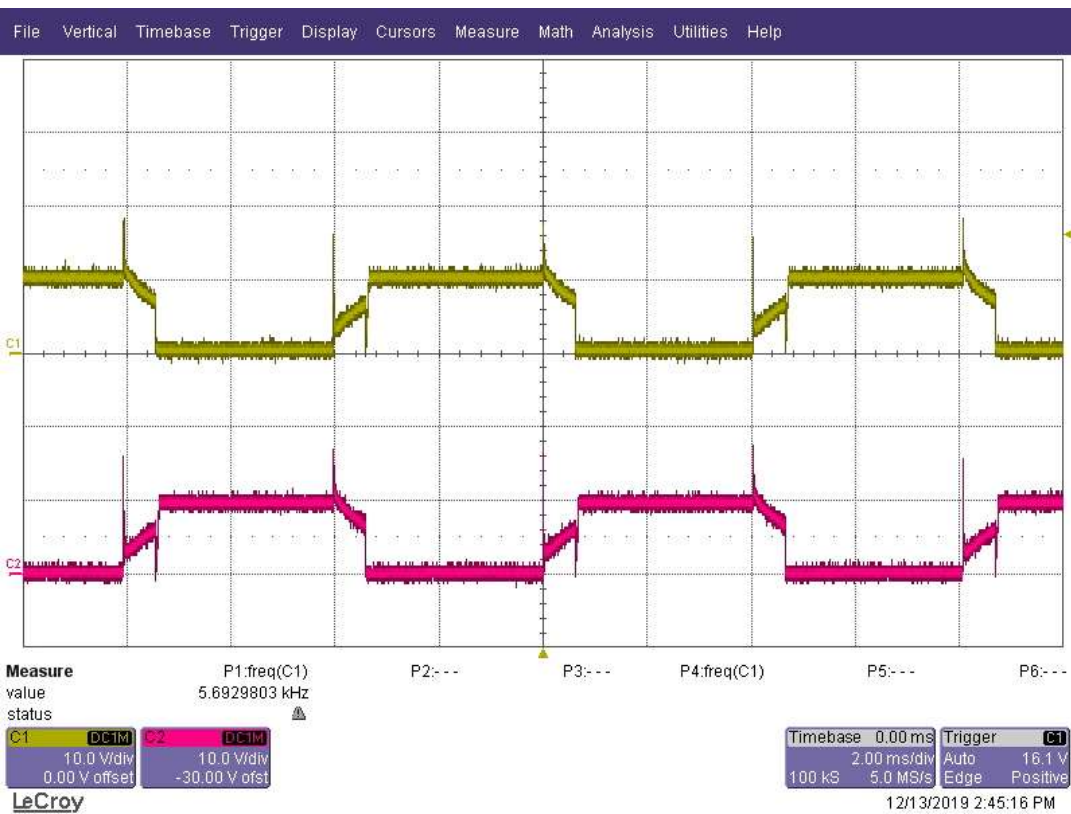
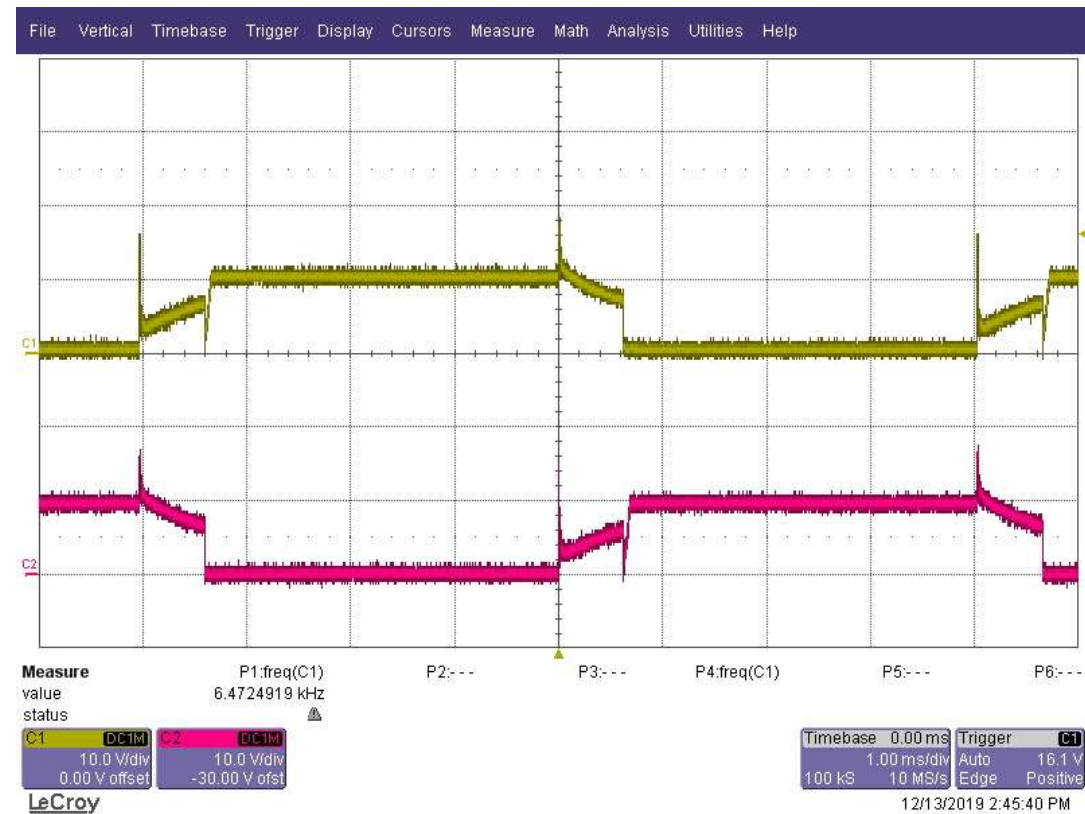
MOSFET Vds waveform, full load condition, added 13-Dec-2019

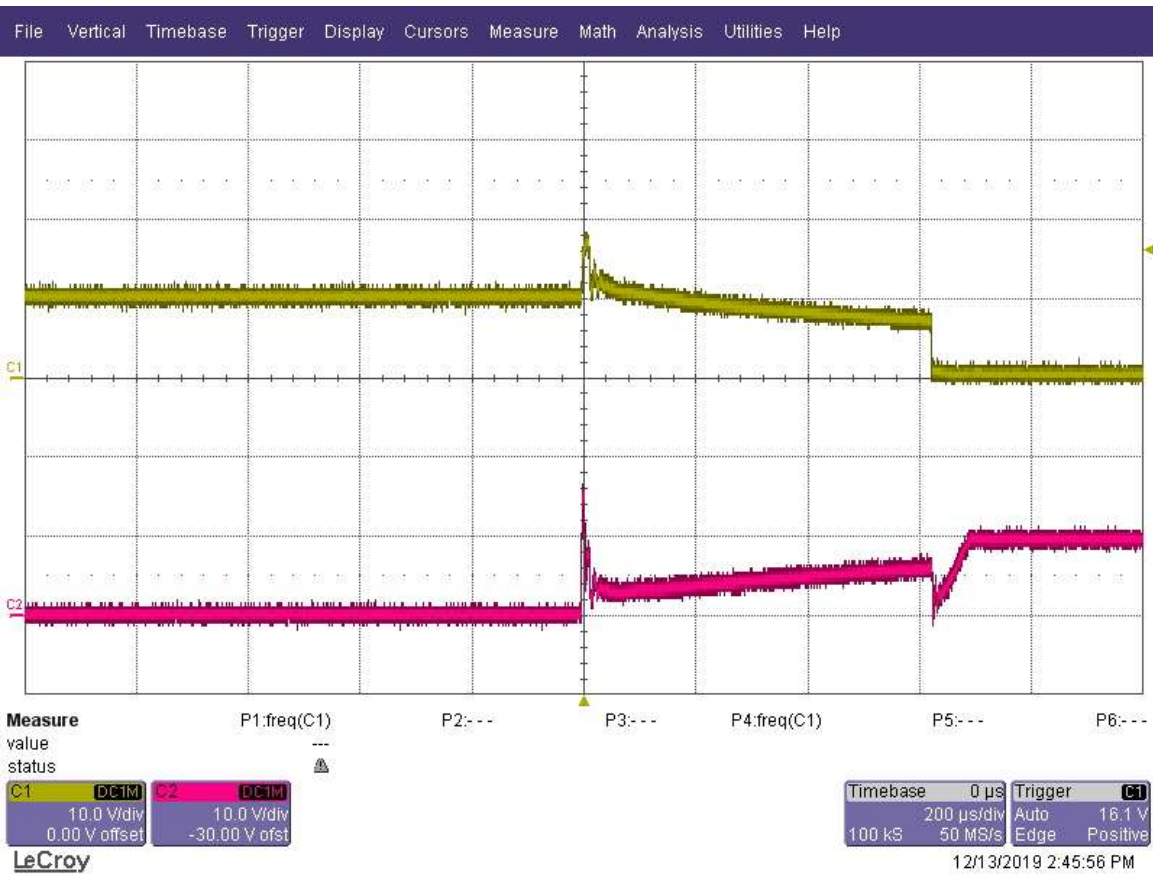
MOSFET Vds waveform, full load condition, spike closeup

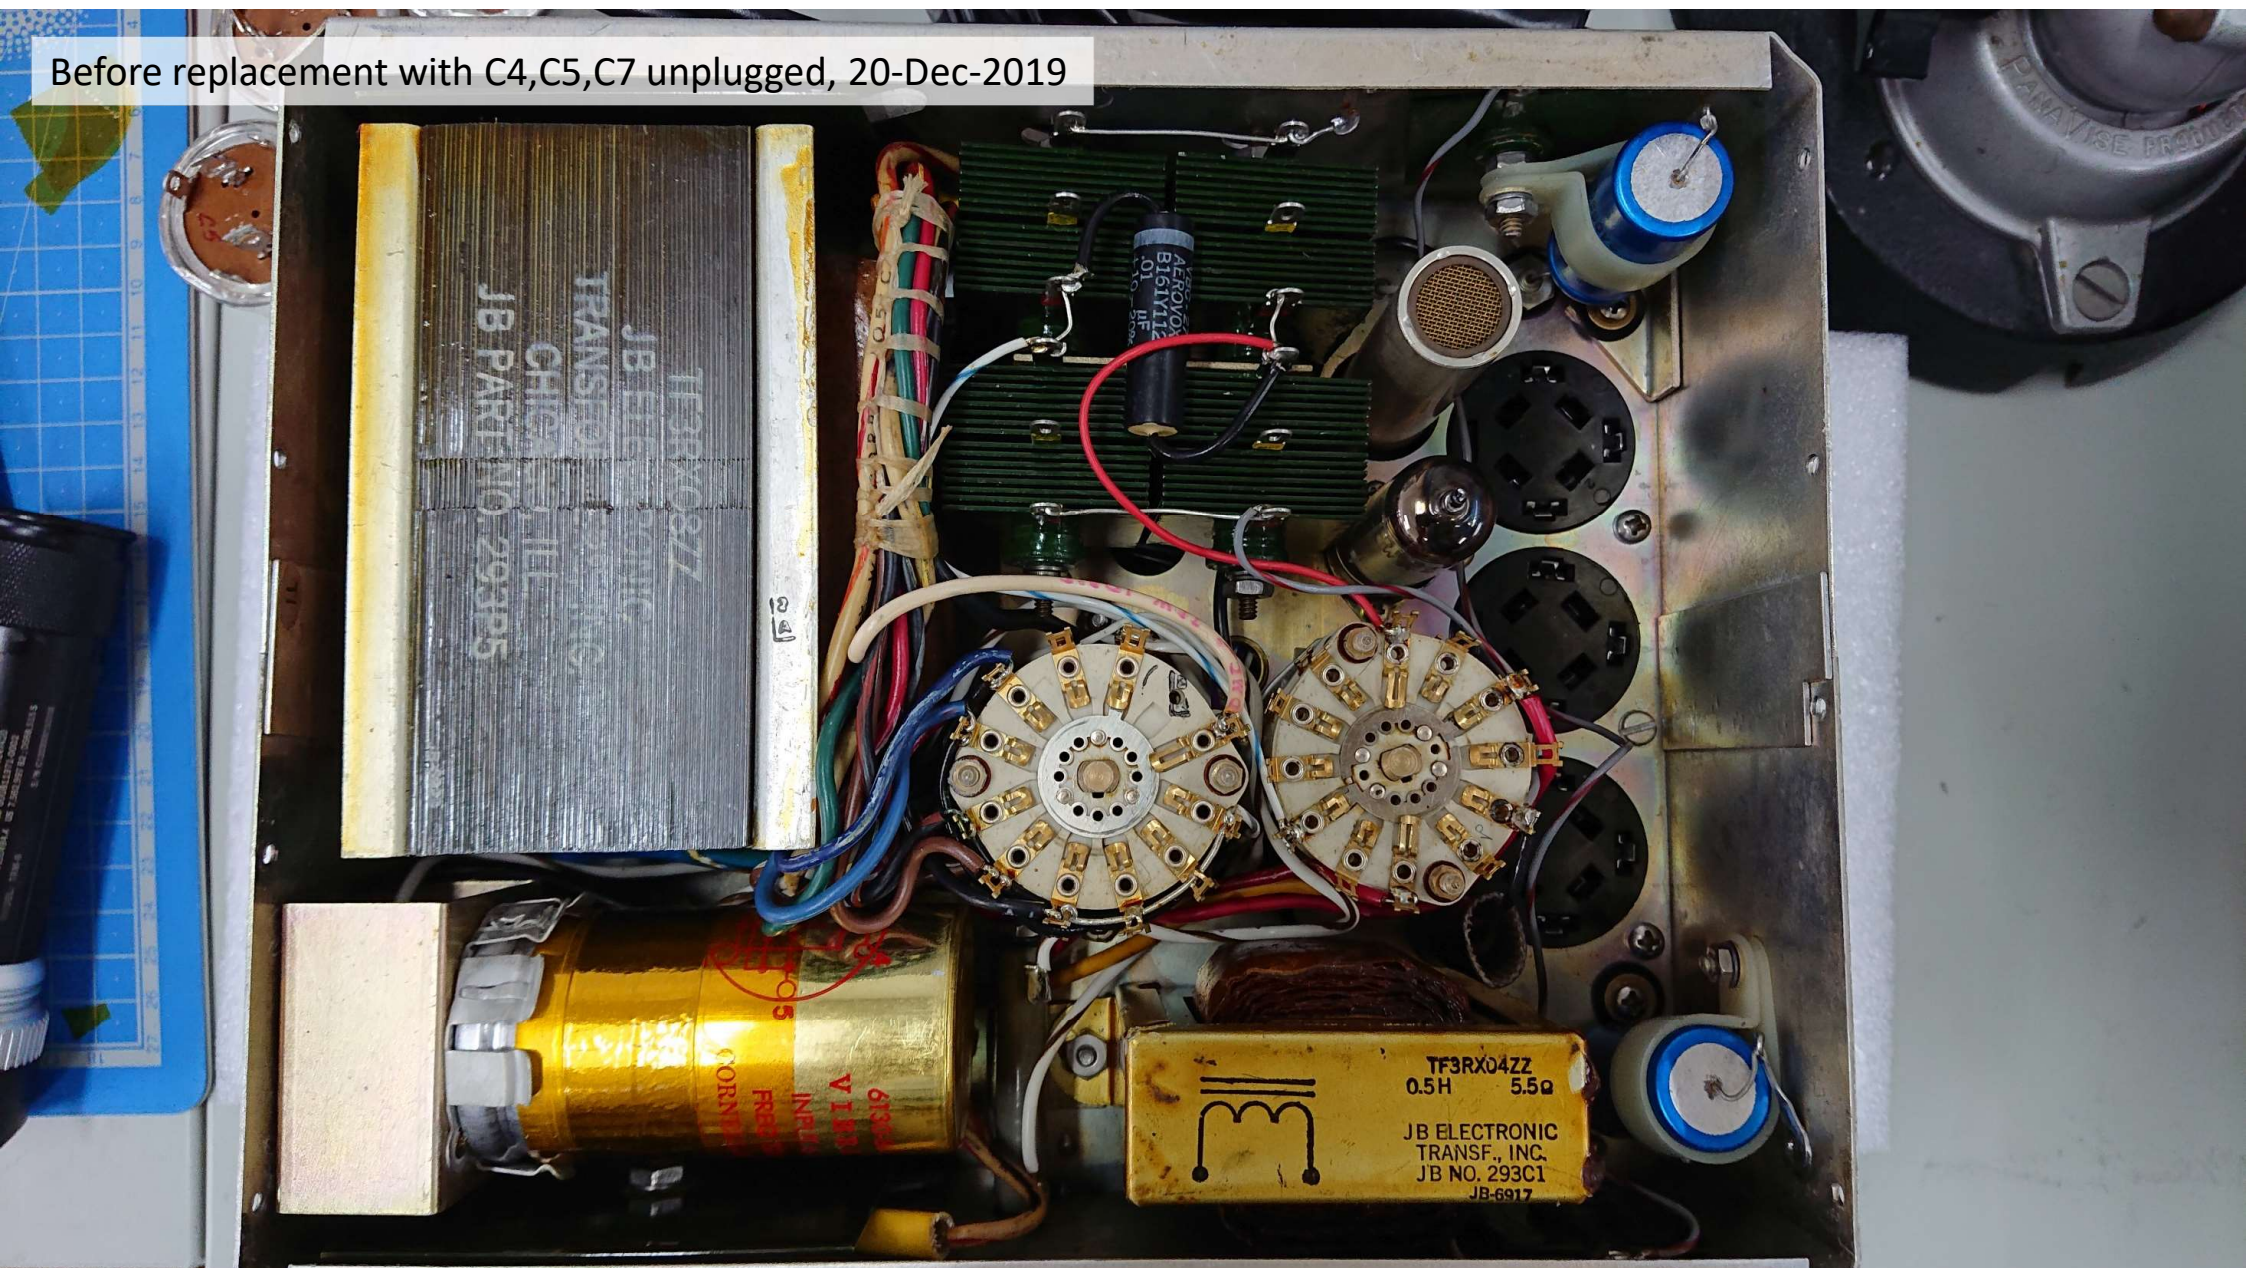
Before replacement , 20-Dec-2019

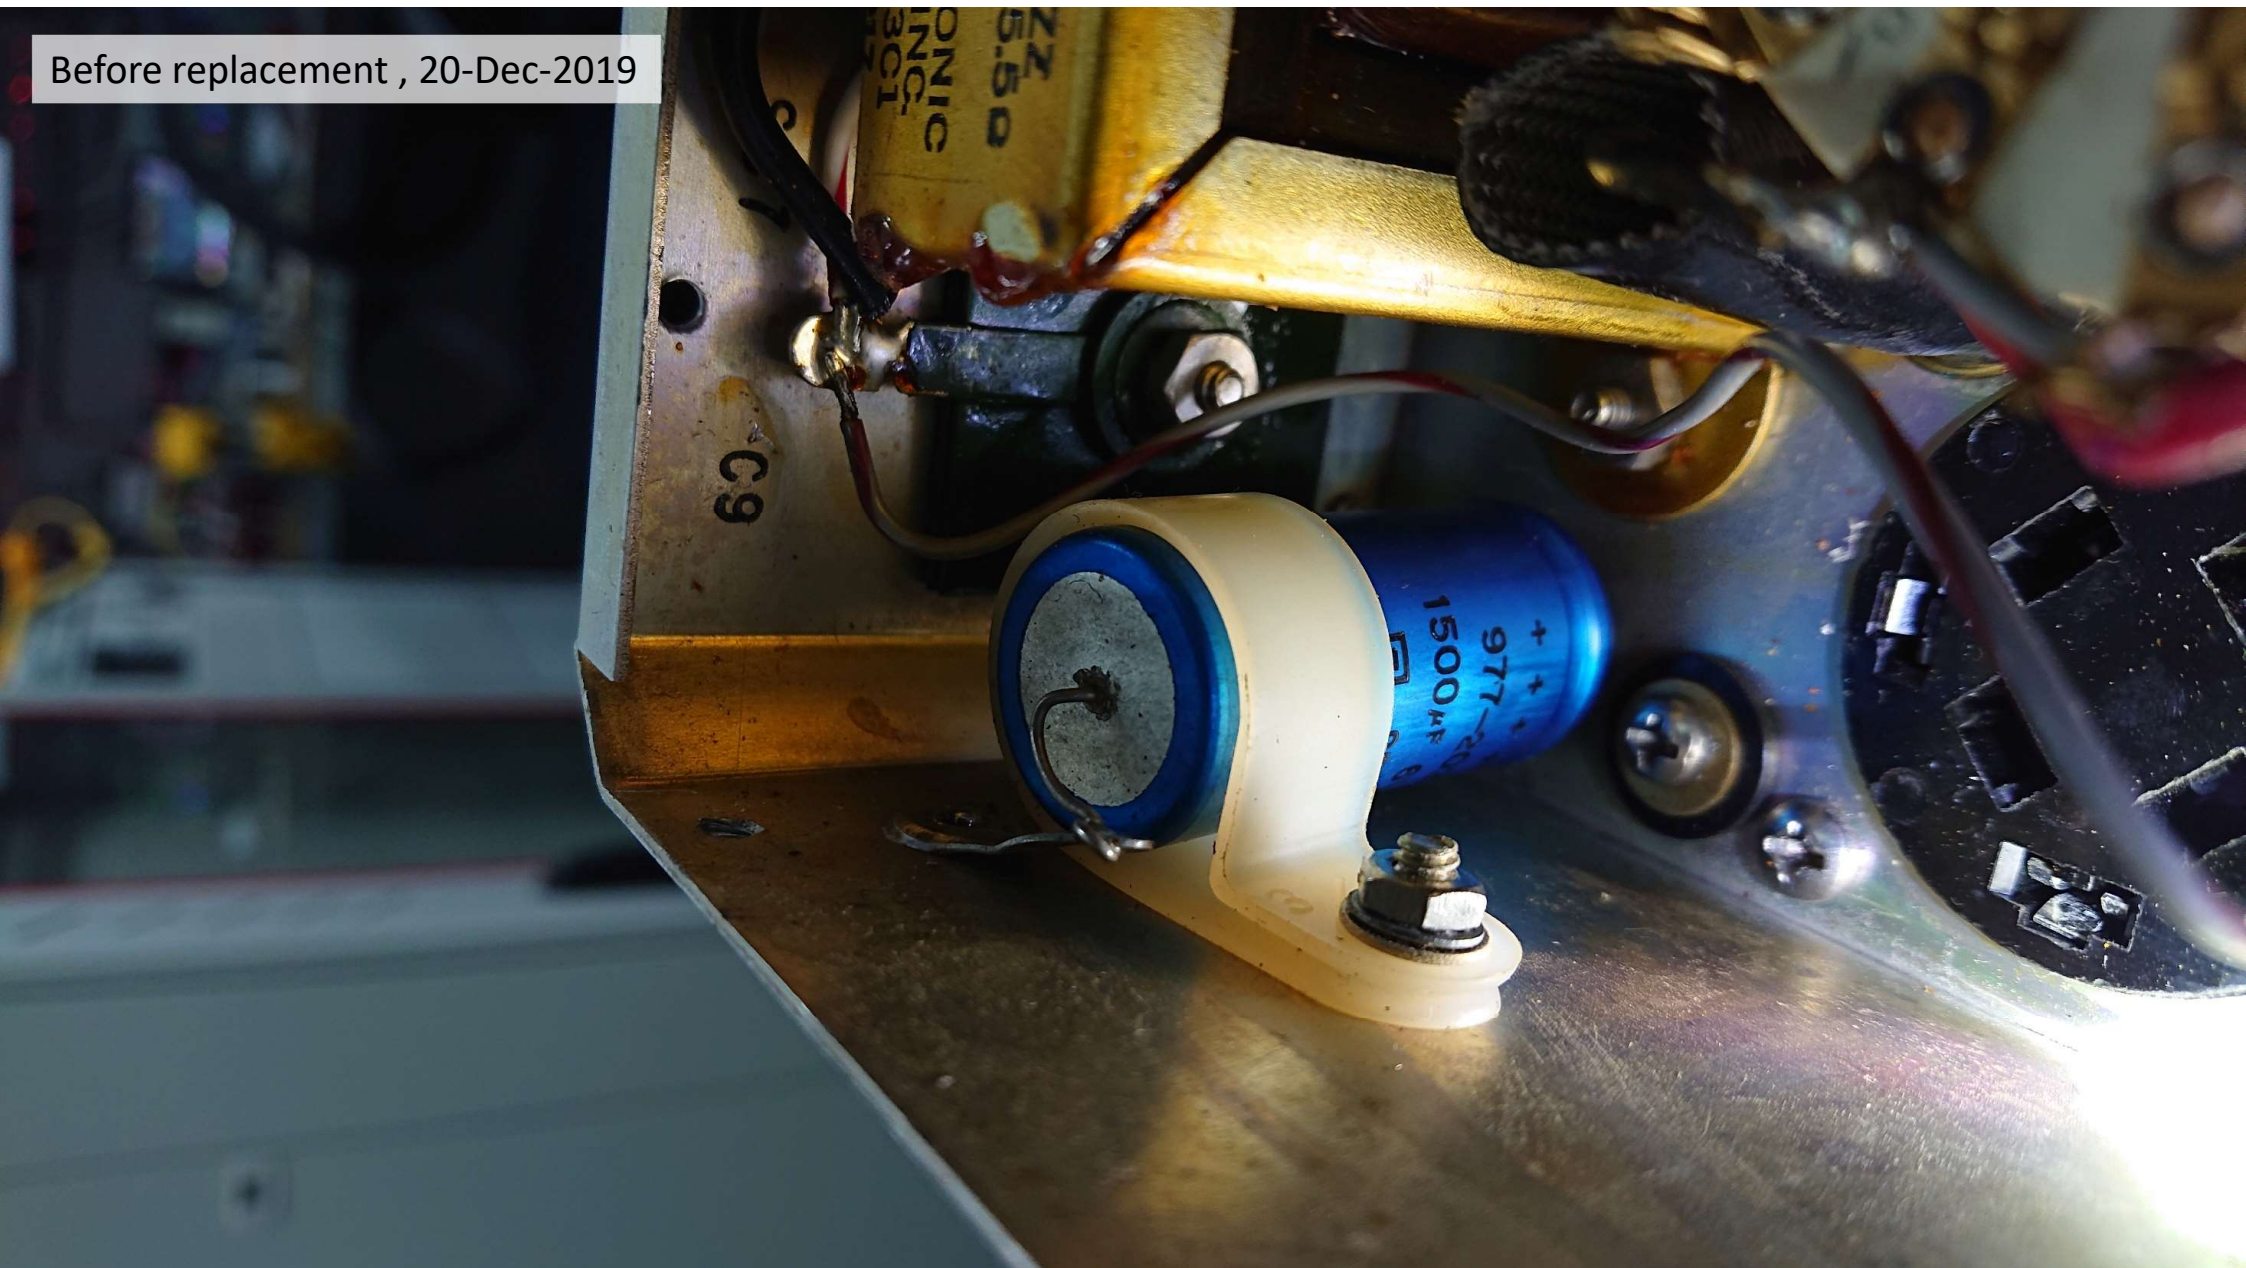
Before replacement C4,C5,C7 unplugged, 20-Dec-2019

The image shows three cylindrical capacitors, likely electrolytic, with metal terminals. The capacitors are silver-colored and show signs of aging and corrosion. The top terminals are unplugged, and the internal brownish liquid is visible. The capacitors are labeled with 'C4', 'C5', and 'C7' in red ink. The left capacitor has 'C4' and '240680' visible. The middle capacitor has 'C5' and '240680' visible. The right capacitor has 'C7' and '240680' visible. The capacitors are sitting on a light-colored surface.

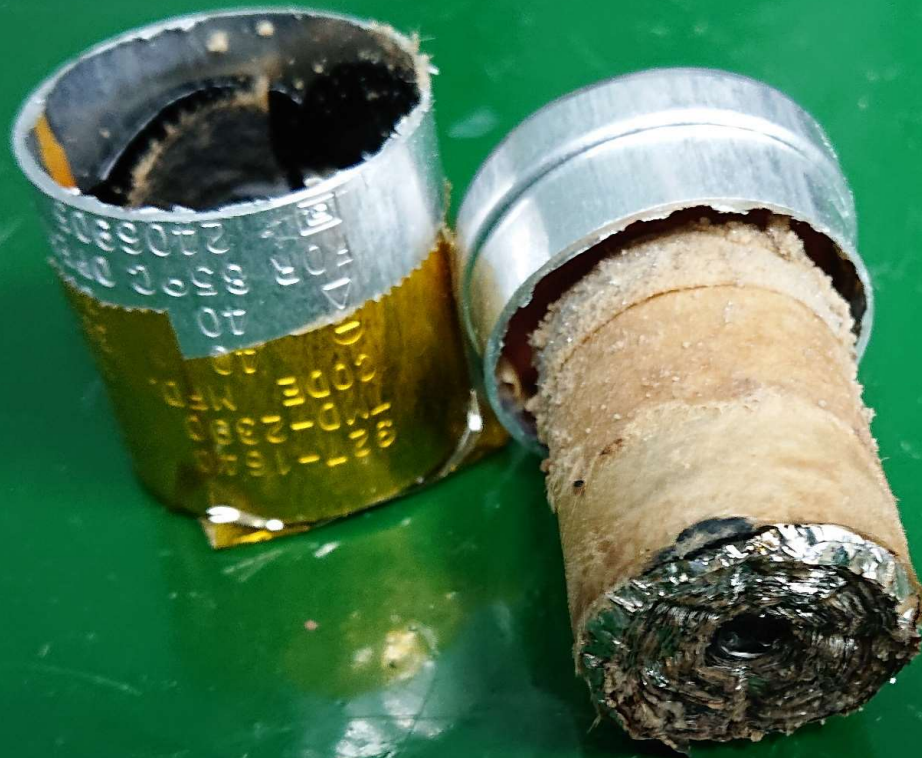
Filament decoupling capacitors removed

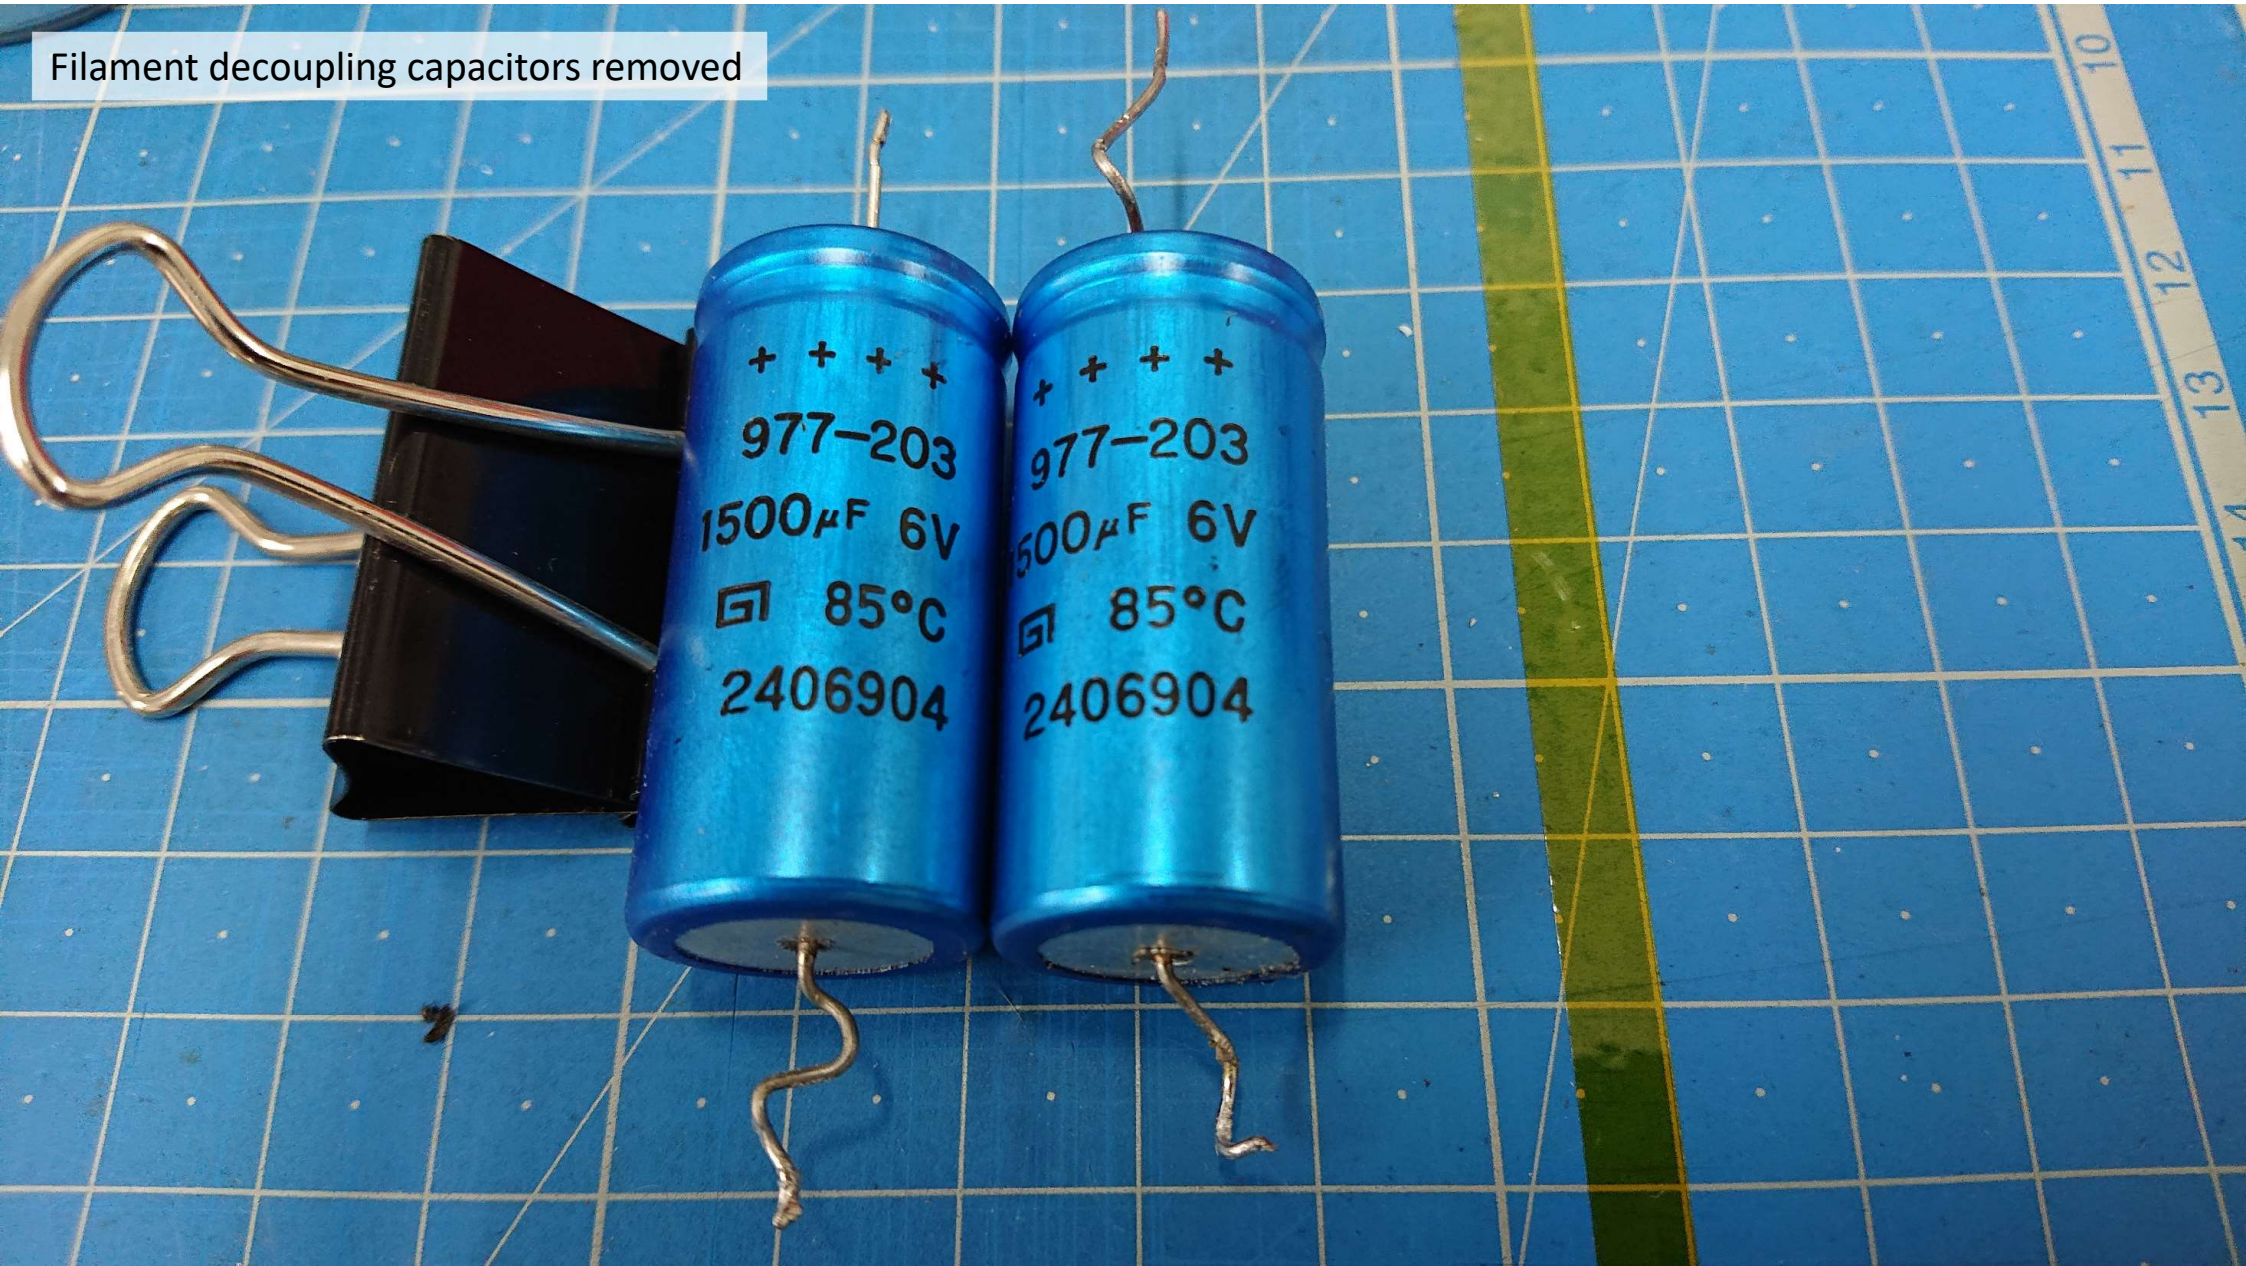
Vibrator mount removed, exposing C1/C2 and L4

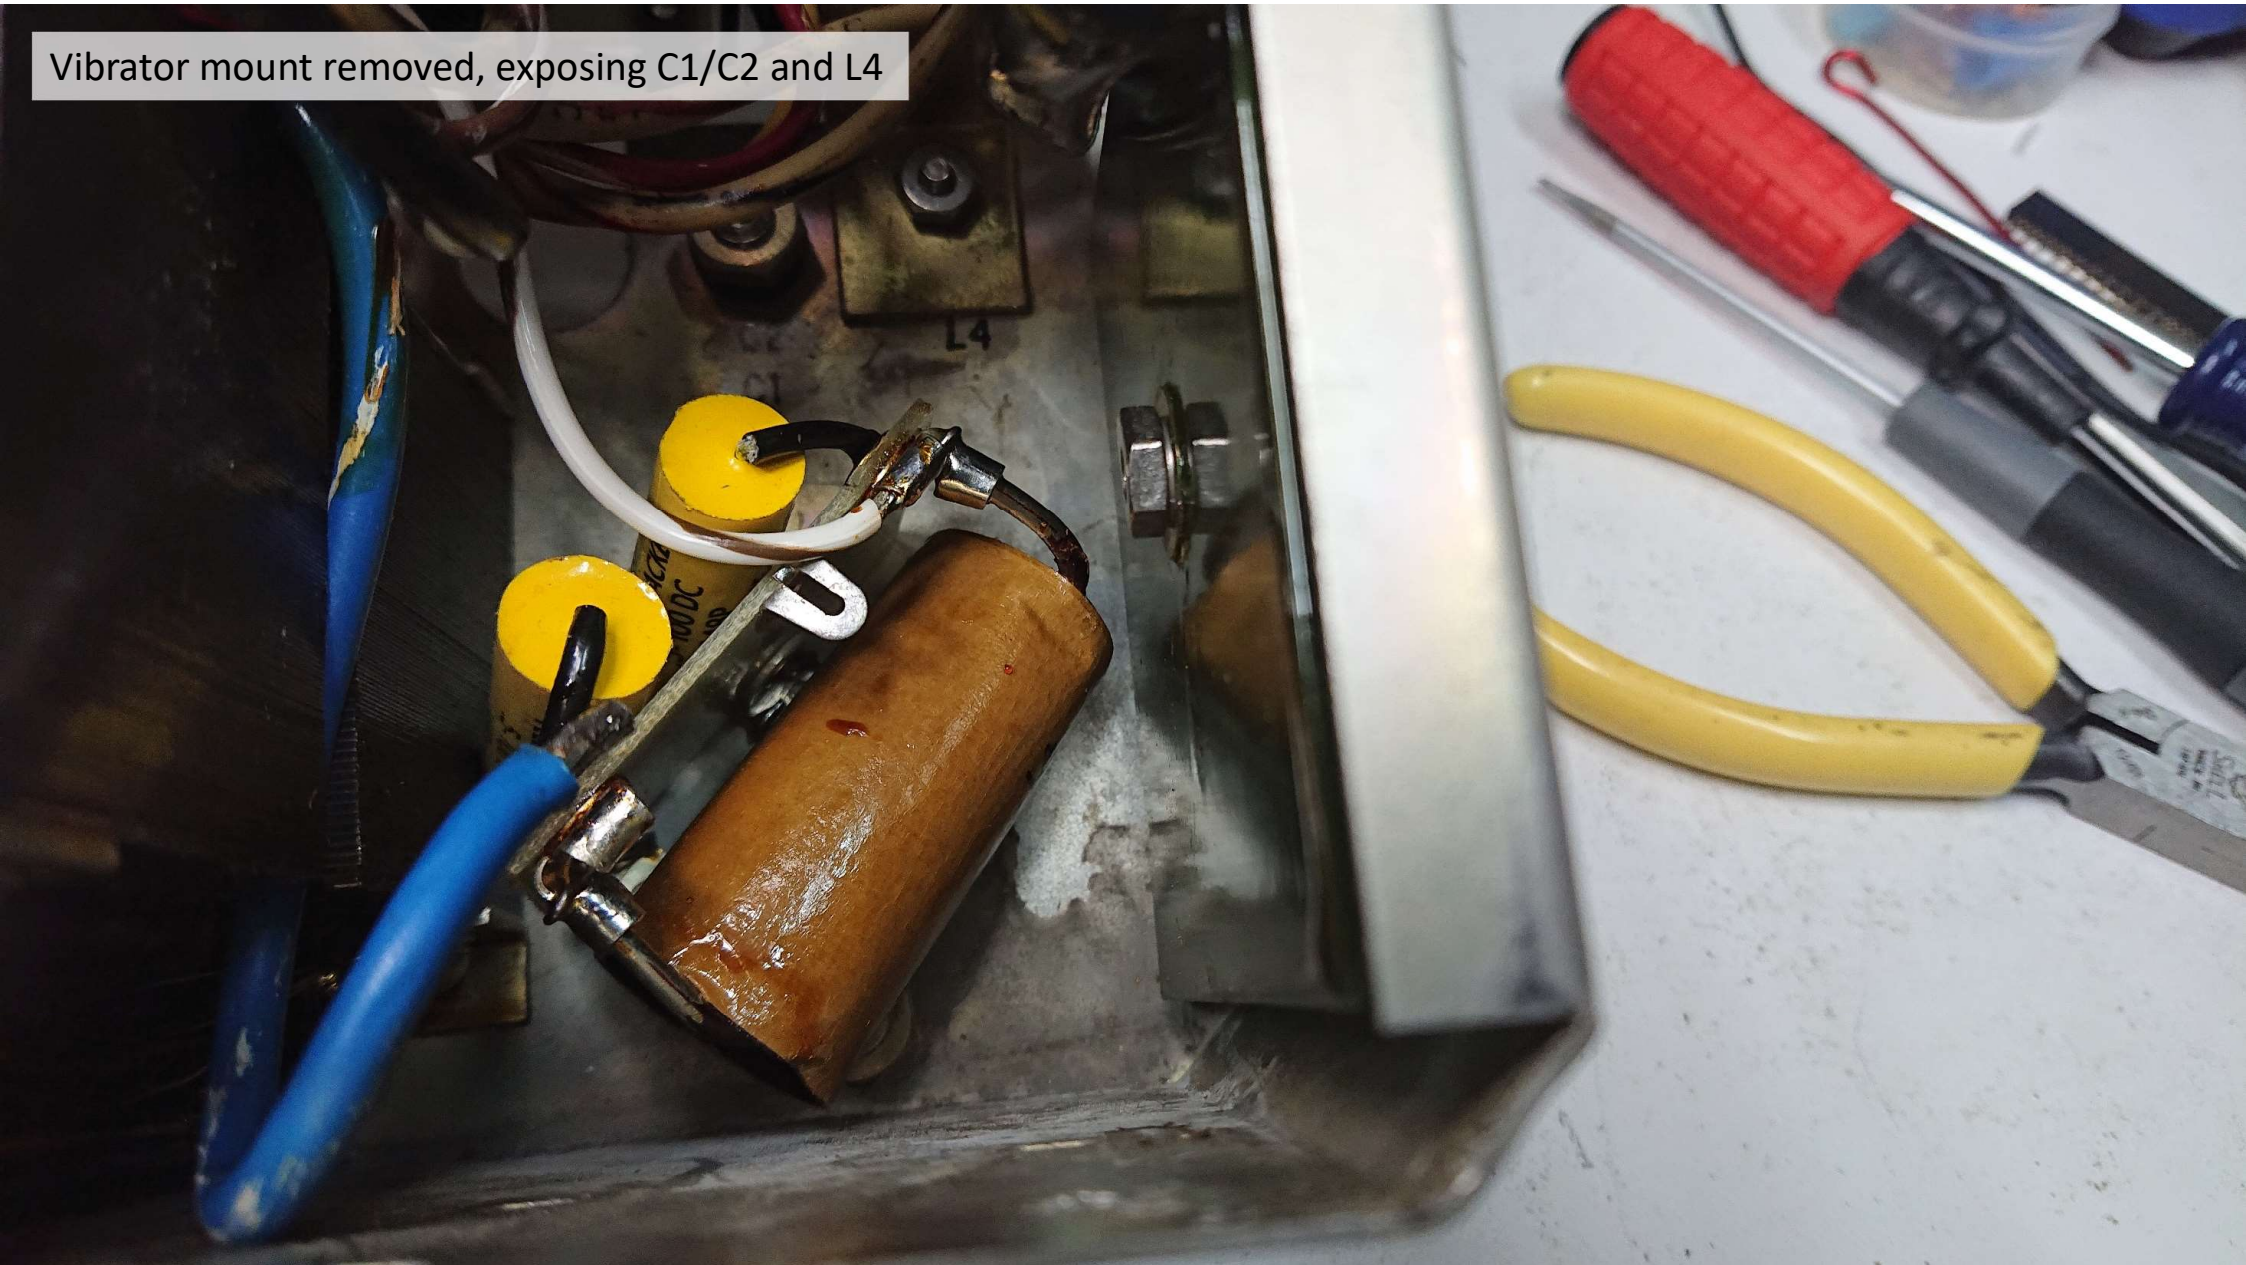
C1/C2 and L4 removed from chassis, L4 measured 3uH at 100KHz

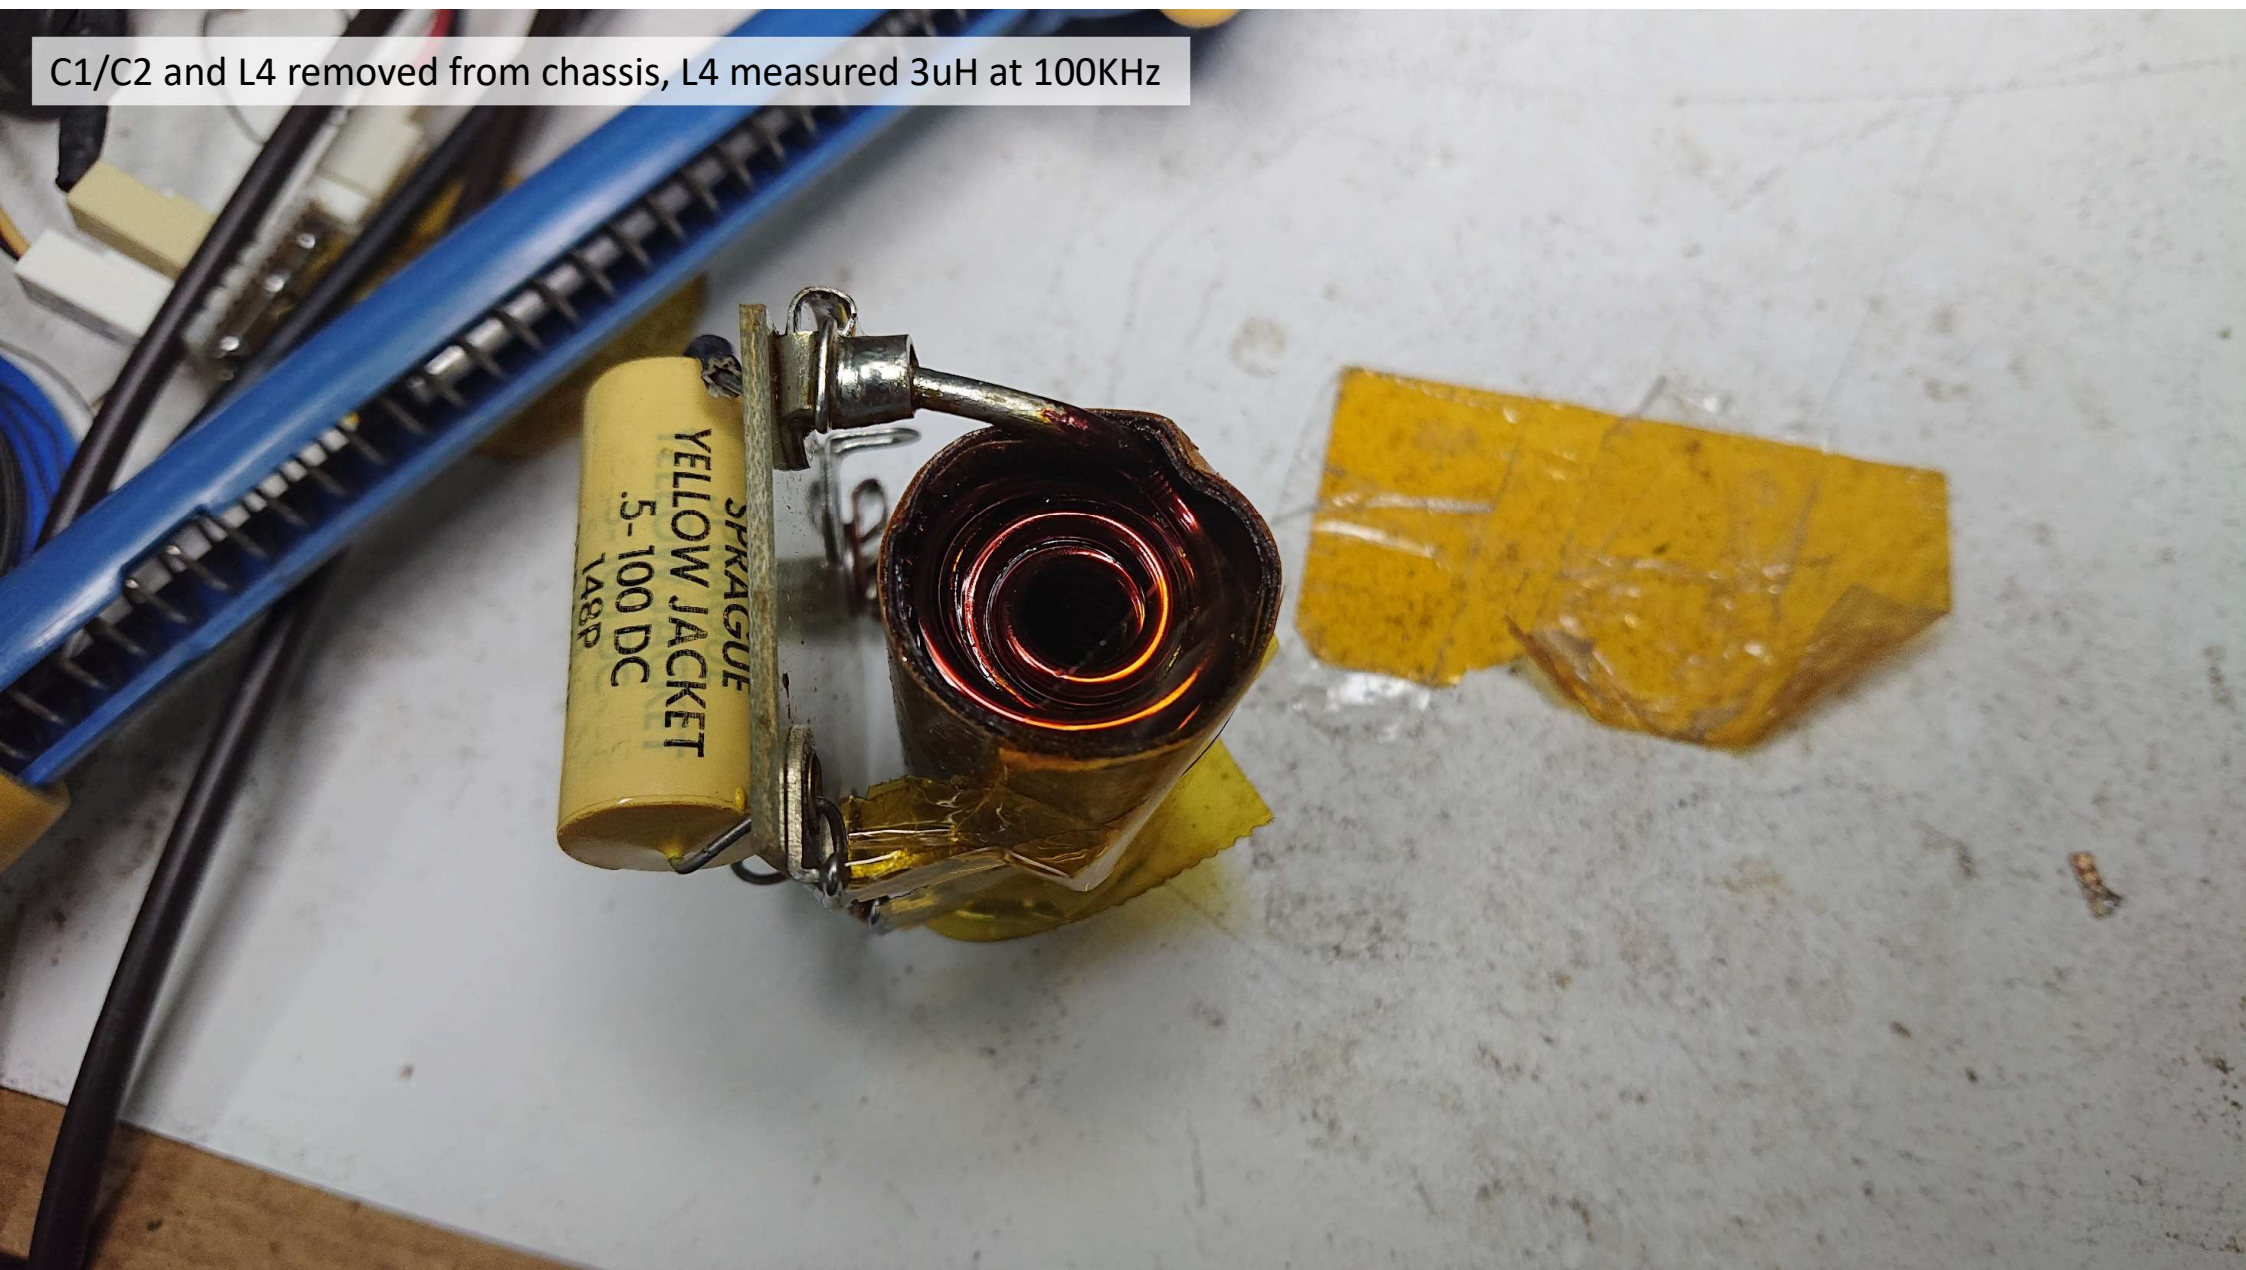
C1/C2 Replaced

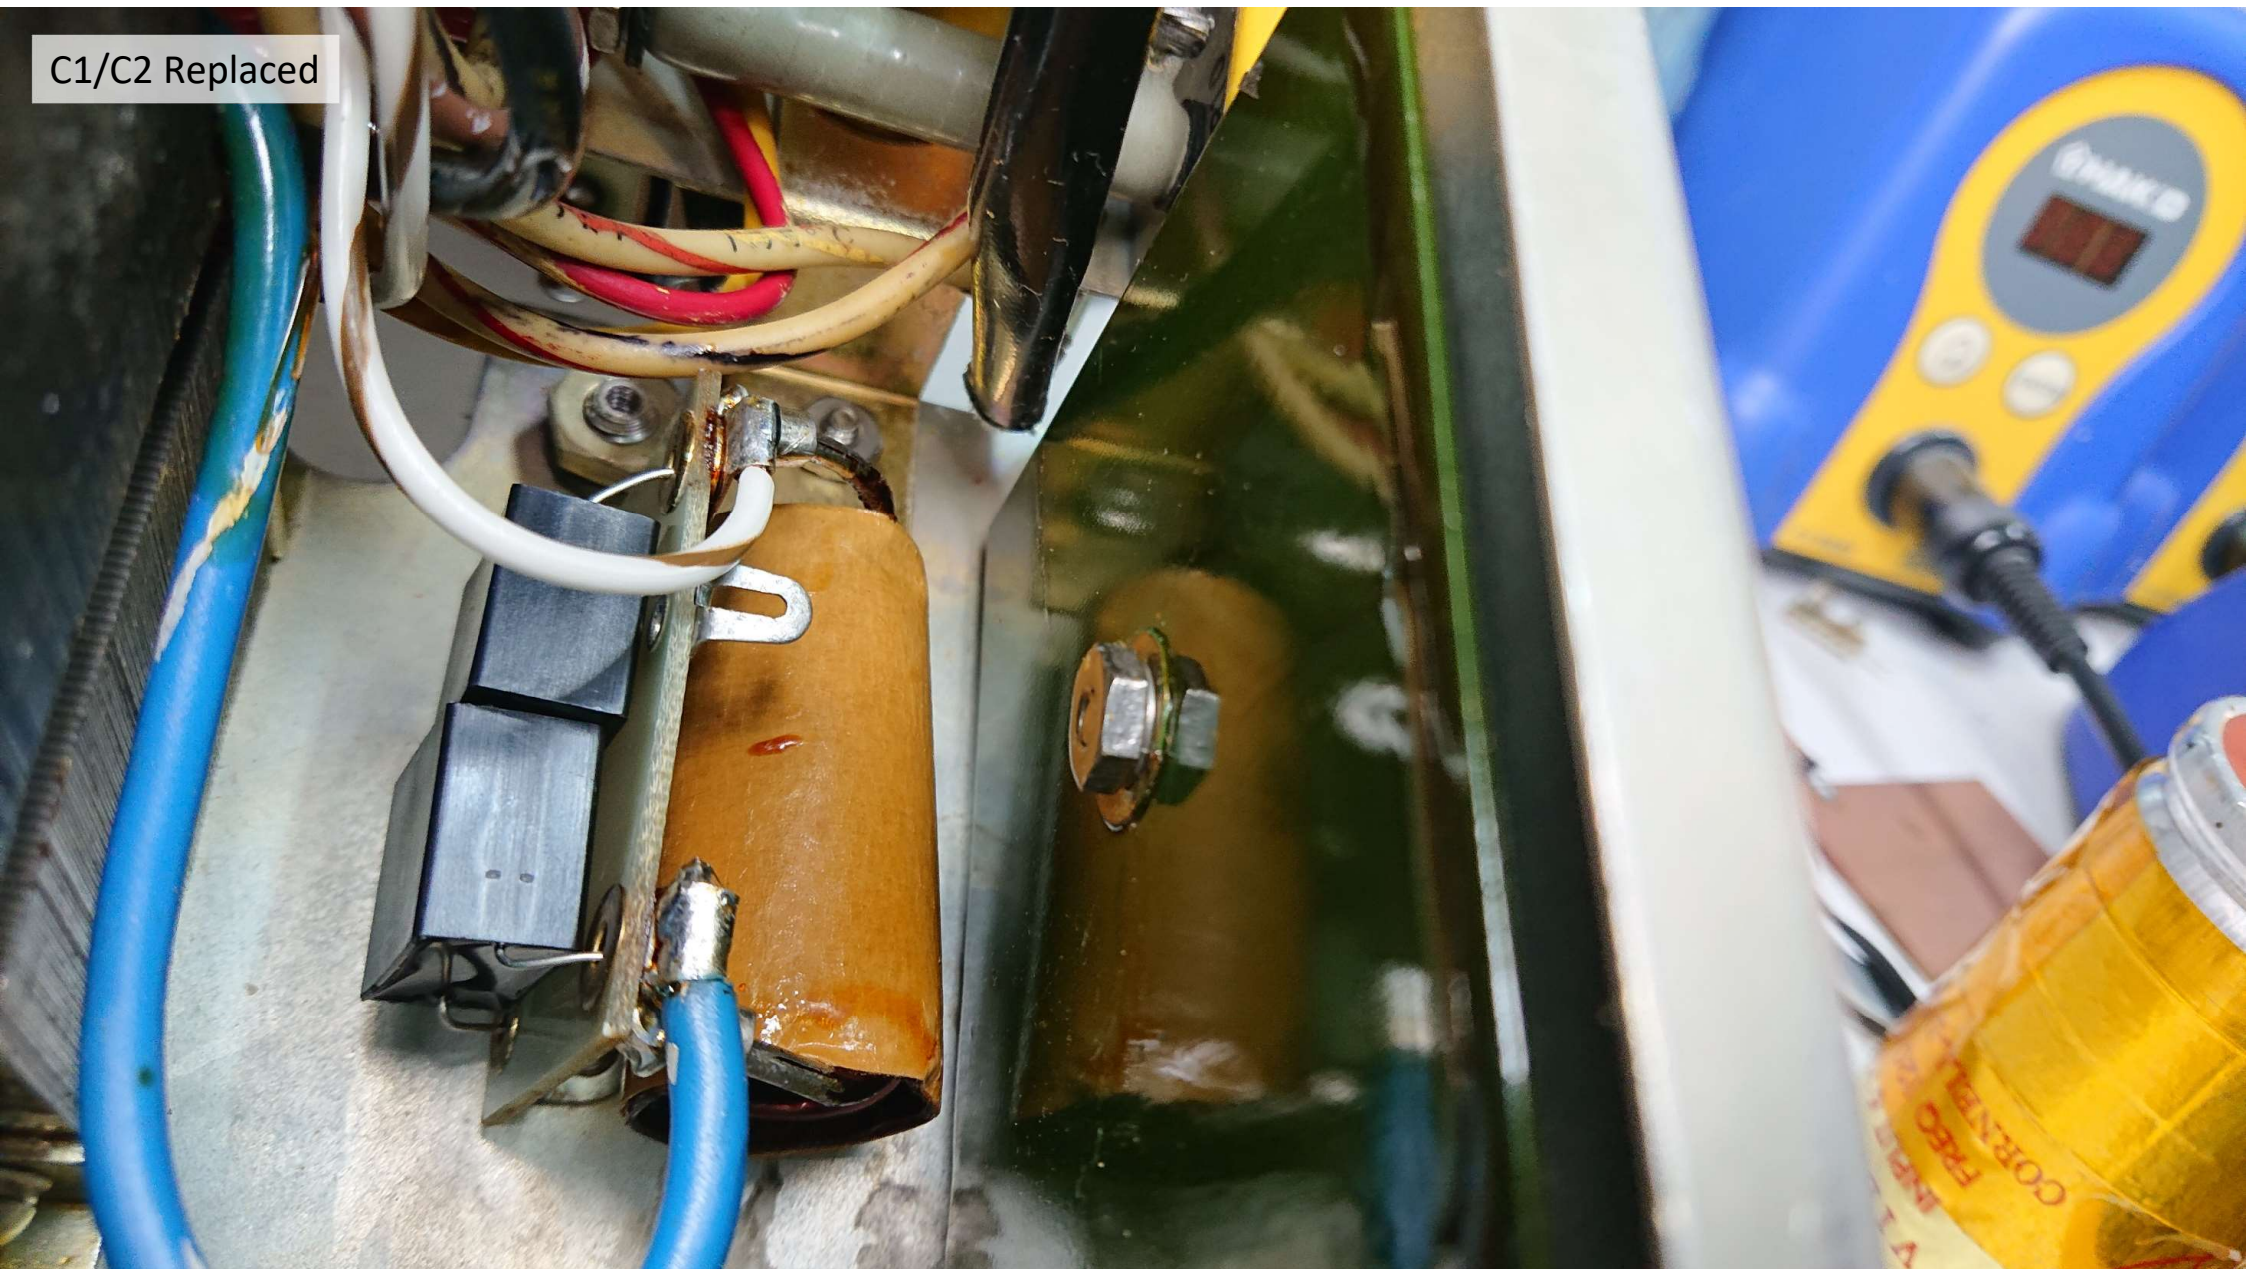
C6 replaced and repositioned
